STRATEGIES FOR REDUCING CEMENT KILN BAGHOUSE CORROSION PROBLEMS

For Presentation at the IEEE/PCA
Cement Industry Technical Conference
Vancouver, British Columbia
May 2001

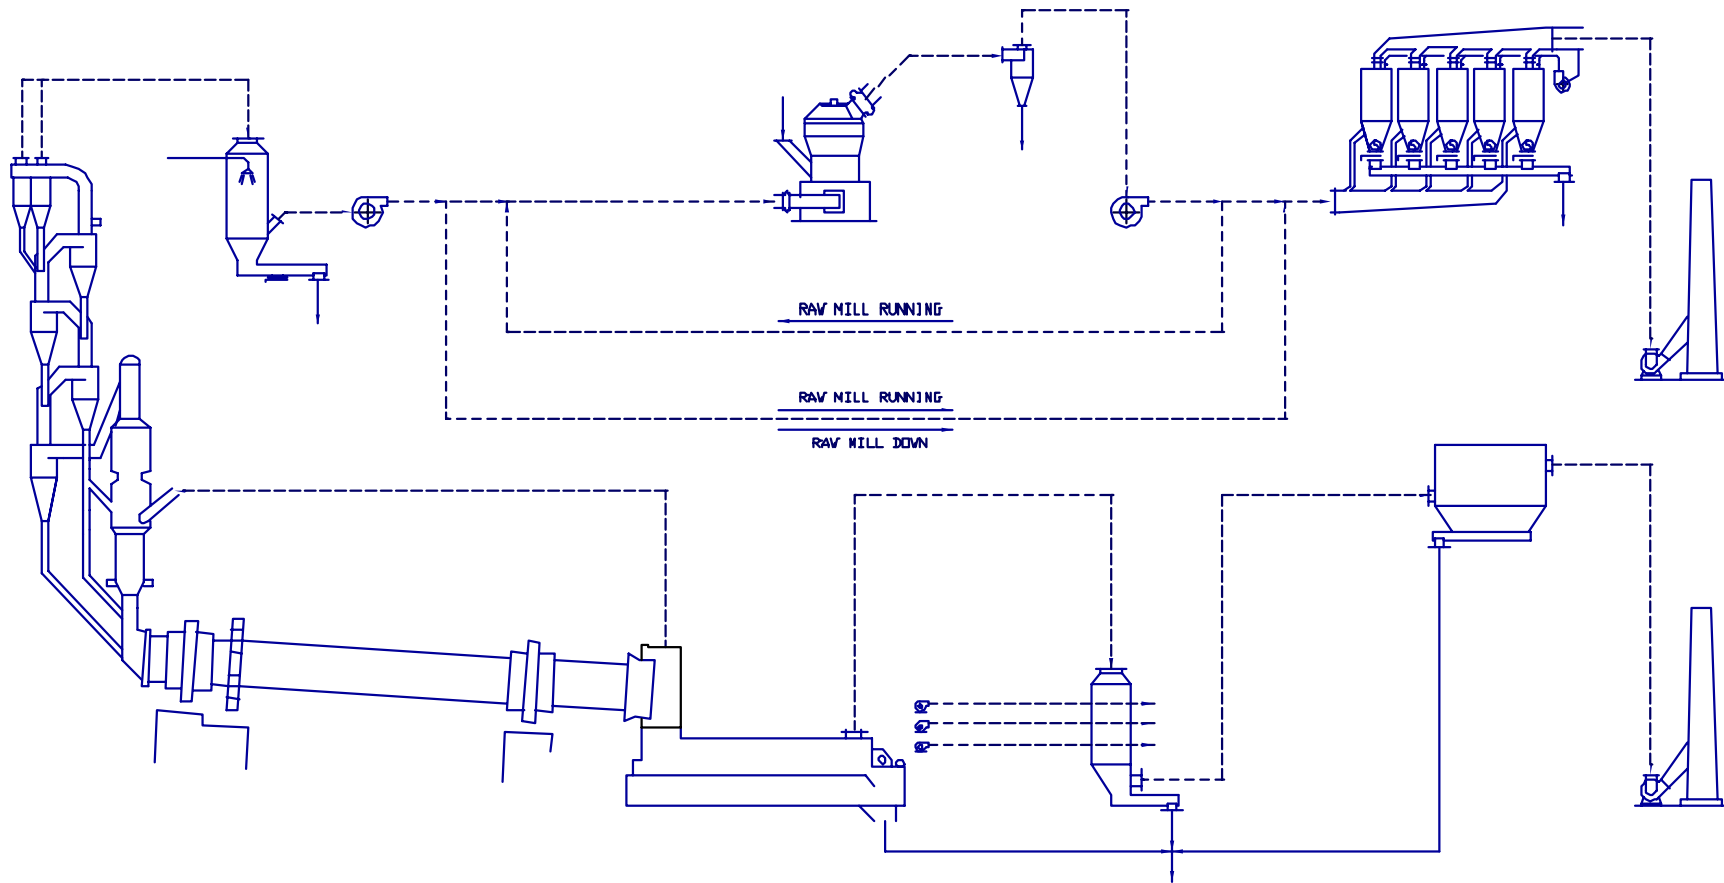
Figure 4 – Preheater/Precalciner Kilns With Partial Bypass Of Kiln Gases Around The Mill

In the case of partial by-pass of kiln gases around the mill, the acid components in the bypass gases are not scrubbed out by the raw mill. When this gas is mixed with the low temperature mill exit gases, the resulting gas mixture is below the acid dew point and corrosion occurs.

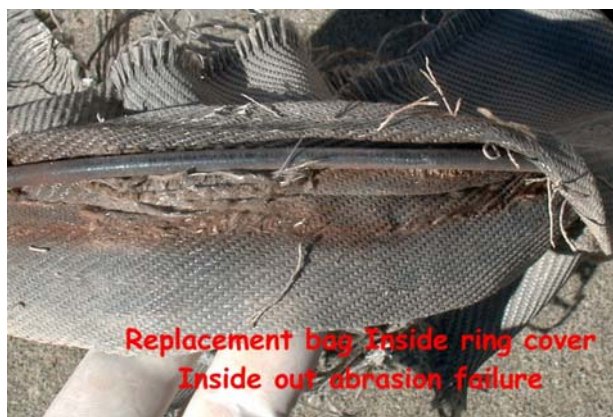
Figure 5 – Bag Ring Corrosion

1. Anti-collapse rings in bags corrode thereby causing wear of the bags from the inside out (Figure 5).
2. Corrosion of tube sheet, collars and tensioning devices causes inadequate bag tensioning and accelerates bag wear (Figure 6)
3. Crystallization of acid compounds in between the glass fiber causes etching and wearing of the glass and advanced wear.

1. Change materials of construction
2. Purchase bag materials that are more acid resistant
3. Use special alloy bag accessories like reverse air anti-collapse rings, cages on jet pulse and bag hardware.
4. Use acid resistive coatings

Some suppliers have acid resistant fabrics using certain fabric finishes that coat the glass fiber better. Also, some suppliers can supply alloy rings and sew them into the bag so that they don't move and cause fabric wear when corroded.

Stainless steel and other alloys sometimes coated with Teflon are used in bag rings, collars, suspension devices and cages to minimize corrosion.

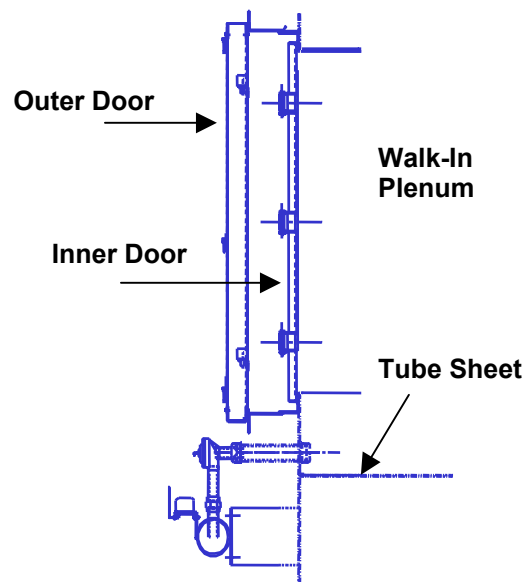
Figure 8 – Insulated Double Door

The details of insulation are very important in preventing condensation. The areas around doors and on doors may be the most difficult. It is an advantage to have a double door arrangement - one door to seal the dust collector and another door to seal the insulation around the dust collector (see Figure 8).
