“Energy conservation through SGA”

**Reduction of fuel oil consumption for anode paste production
from a level of 25 L/Mt to 10 L/Mt.**

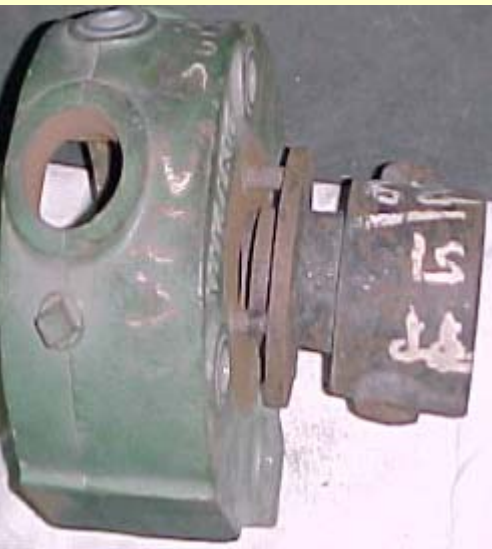
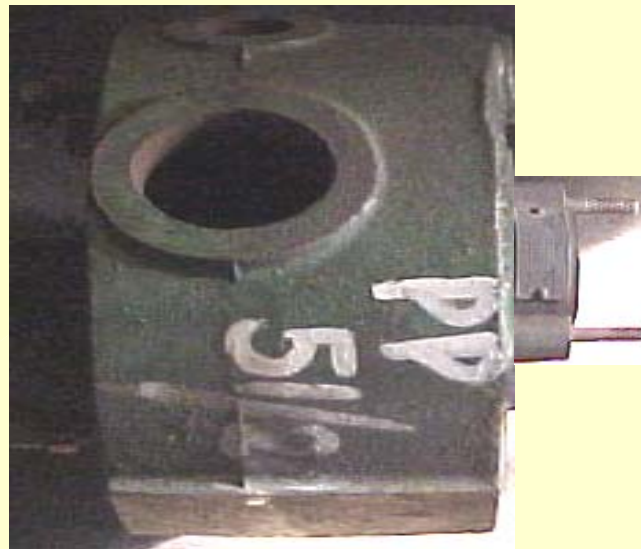
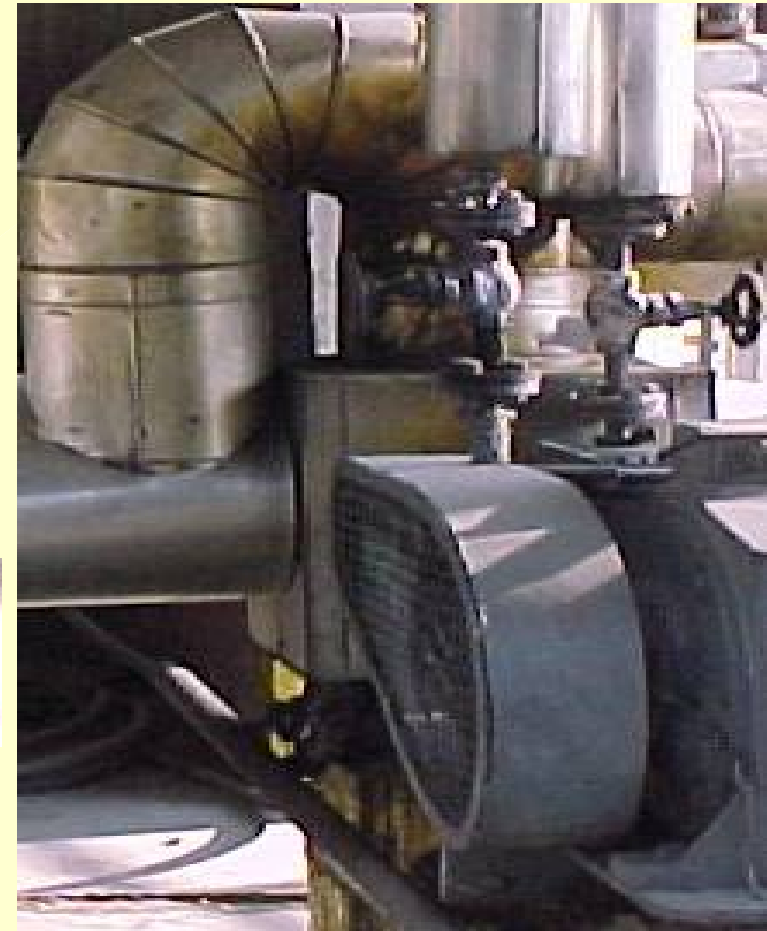
Modification of Pitch pump

Frequent tripping of Pitch delivery pump.

Pitch inside the pump not getting melted due to inadequate temperature.

Thermally conducting cement was replaced with thermic fluid heating system.

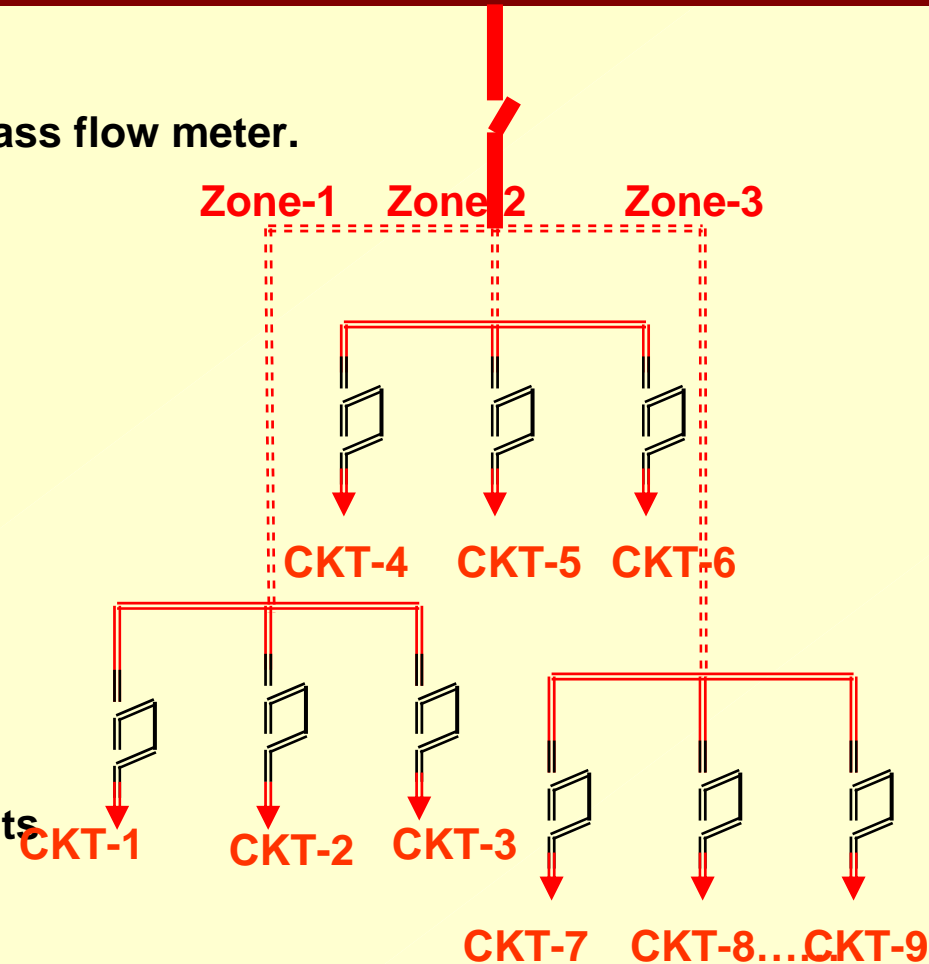
Circuit modification

1. Less flow rate of Pitch as indicated by the mass flow meter.
2. Pump motor draws high amperage.

- ▶ Observed Zone #3' drawing less current.
- ▶ Not reflected in temperature indicator.

1. Subdivision of Zones into circuits
2. No. of ammeters & temperature sensing points were increased to 9 nos from 3 nos.

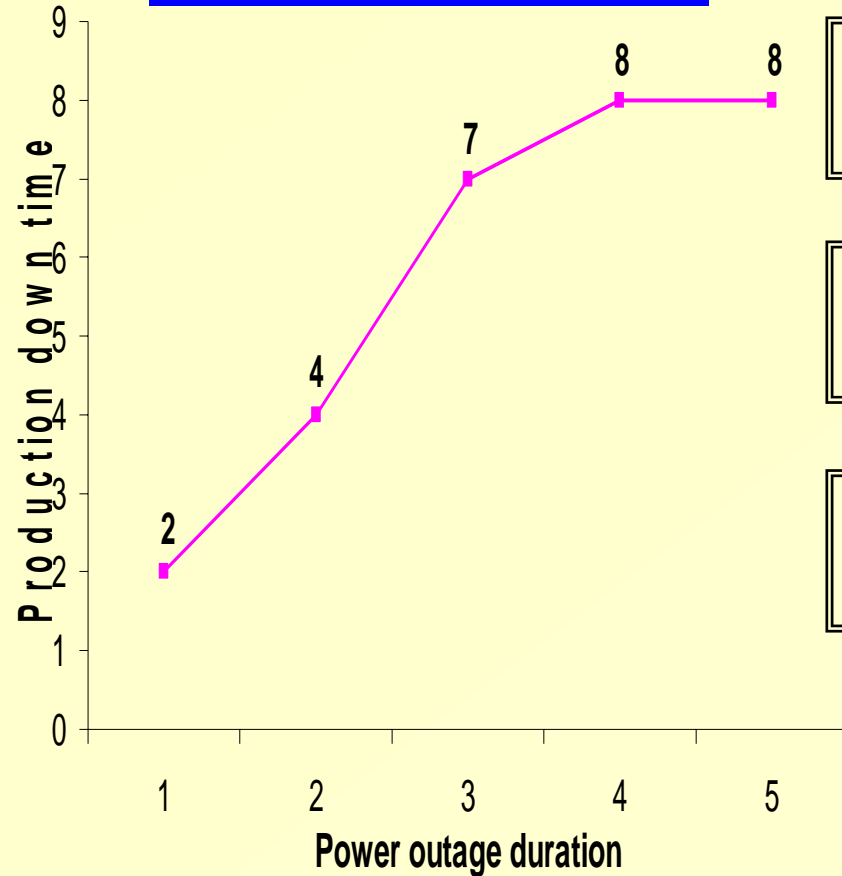
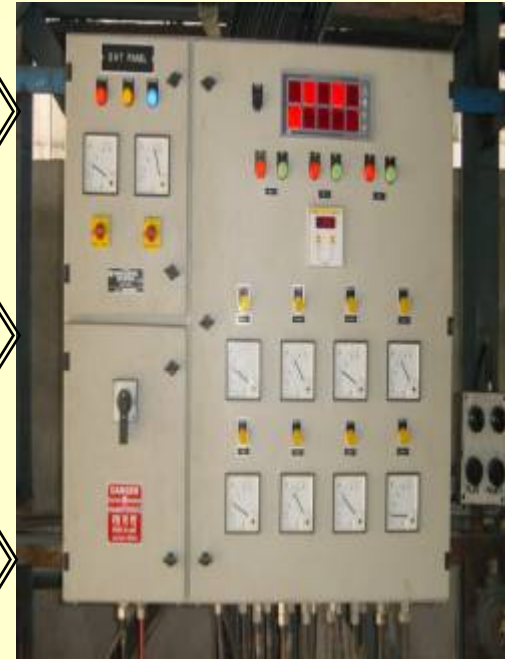
Failure prevention against power supply interruption

Impact of Power failure: -

► Simulation study

Power outage vs. Production down time
