ITC HOTEL SONAR BANGLA SHERATON & TOWERS

TECHNICAL PRESENTATION

IMPLEMENTATION OF ENERGY CONSERVING PROJECTS AND THEIR RESULTS

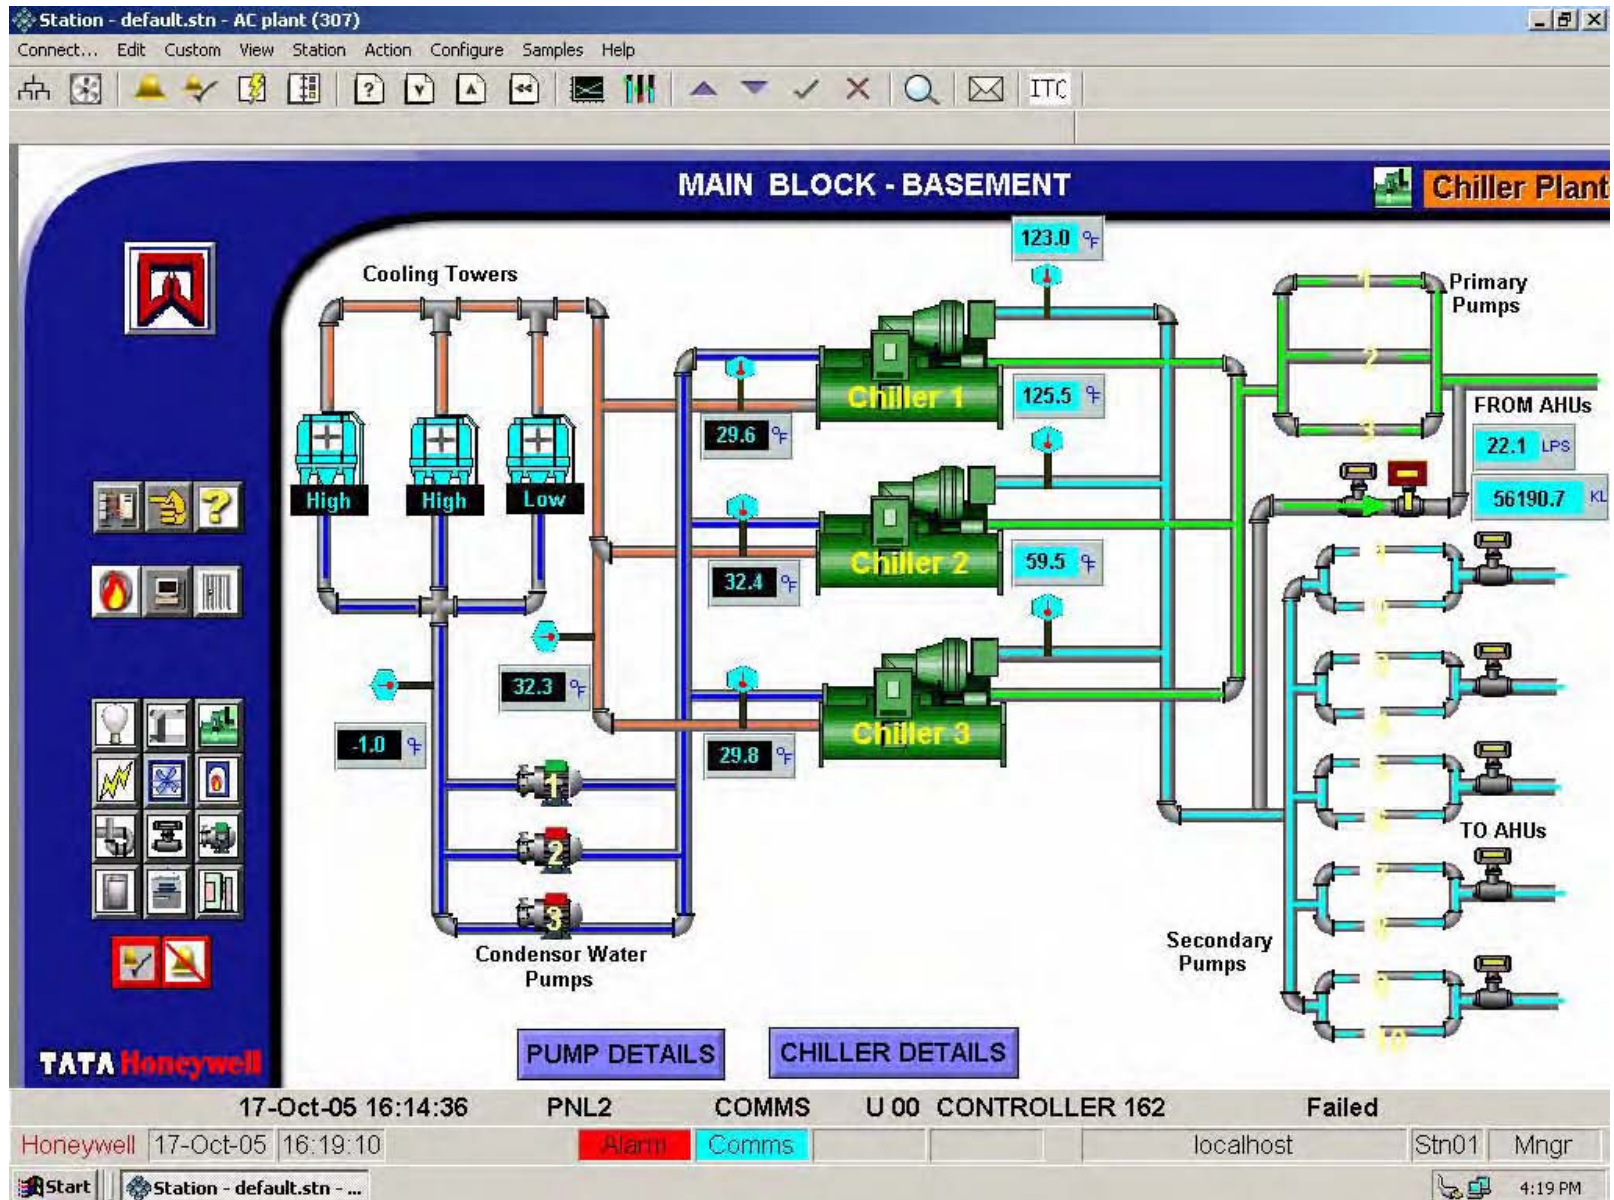
Below figure shows the chiller system of the hotel that can be monitored as well as controlled by BMS

- The a/c system used is of centralized type having screw chillers which are low energy consuming and with two way system I.e. primary and secondary pumping system.
- The secondary system is provided with VFD's and pressure transducers at the farthest points thereby operating the pumps at the optimum speed depending upon the a/c load

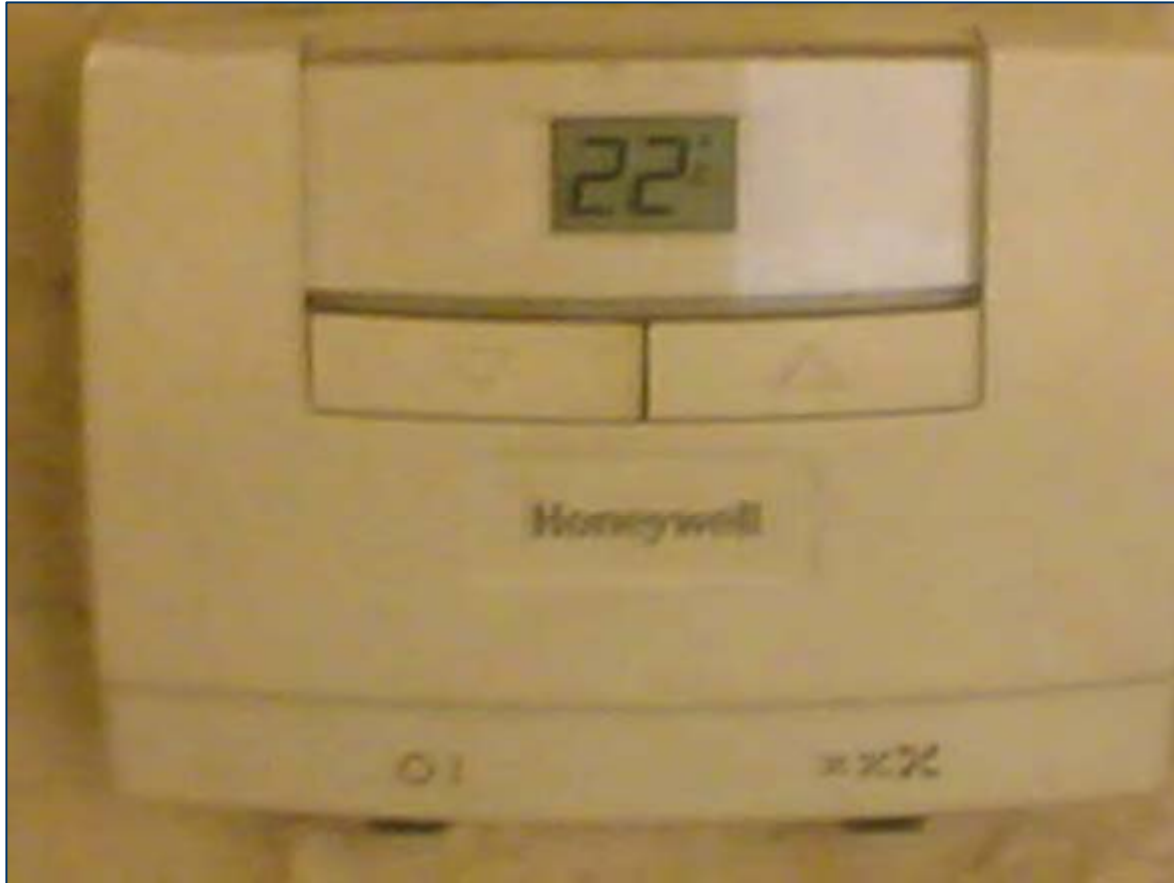
- The rooms are provided with individual thermostats with two settings one maintaining the occupied temperature set by the occupant and the second maintaining the default setting set for a vacant room

Thermostats displaying the standard occupied temperature of 22 degc

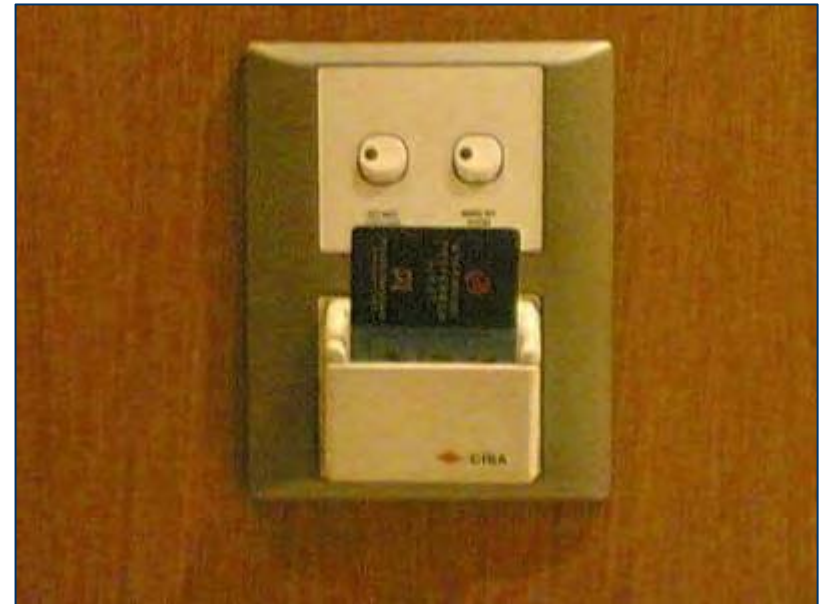
- The guest rooms in the hotel are also designed for maximum comfort and minimum energy consumption
- The guestrooms are provided with key cards through which the electrical supply is given to the room so that if the room is unoccupied there is no supply hence conserving energy.

The above figure shows the key card in an activated position

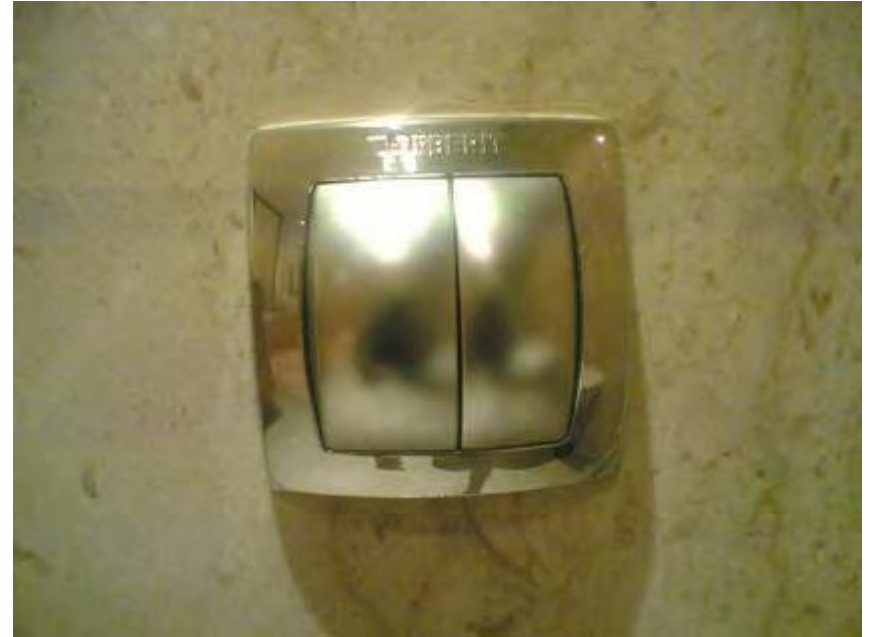
- The rooms are provided with a dual flushing system of **3 ltrs** and **9 ltrs** discharge depending upon the requirement.

The above figure displays the dual system flushing knobs used in the guest rooms for discharging the required amount of water depending upon the usage.

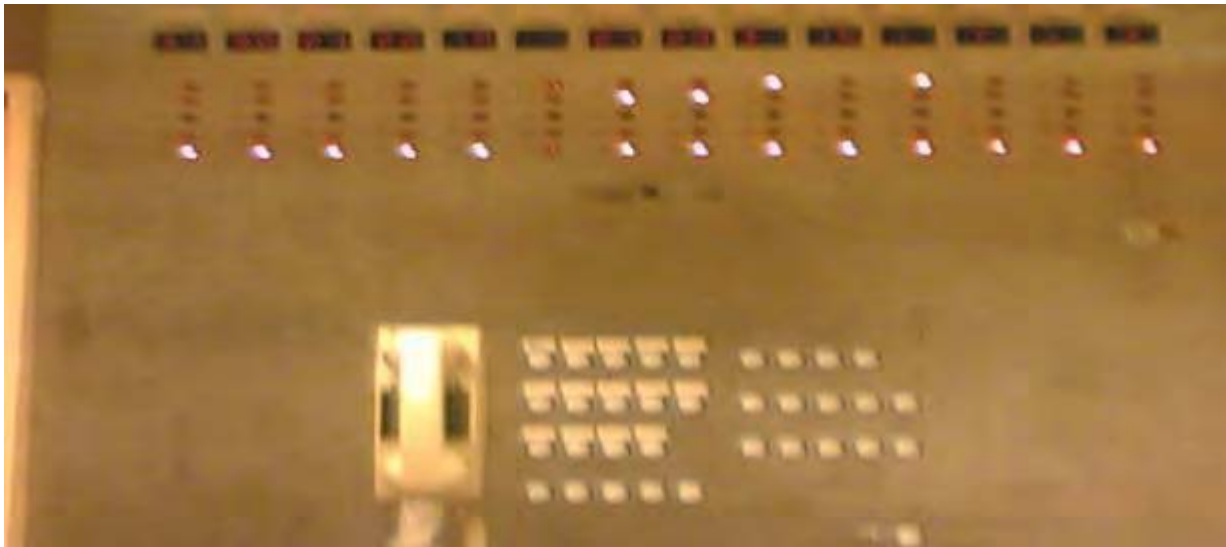
Above shown is the manual rescue call receiving centre of the elevators

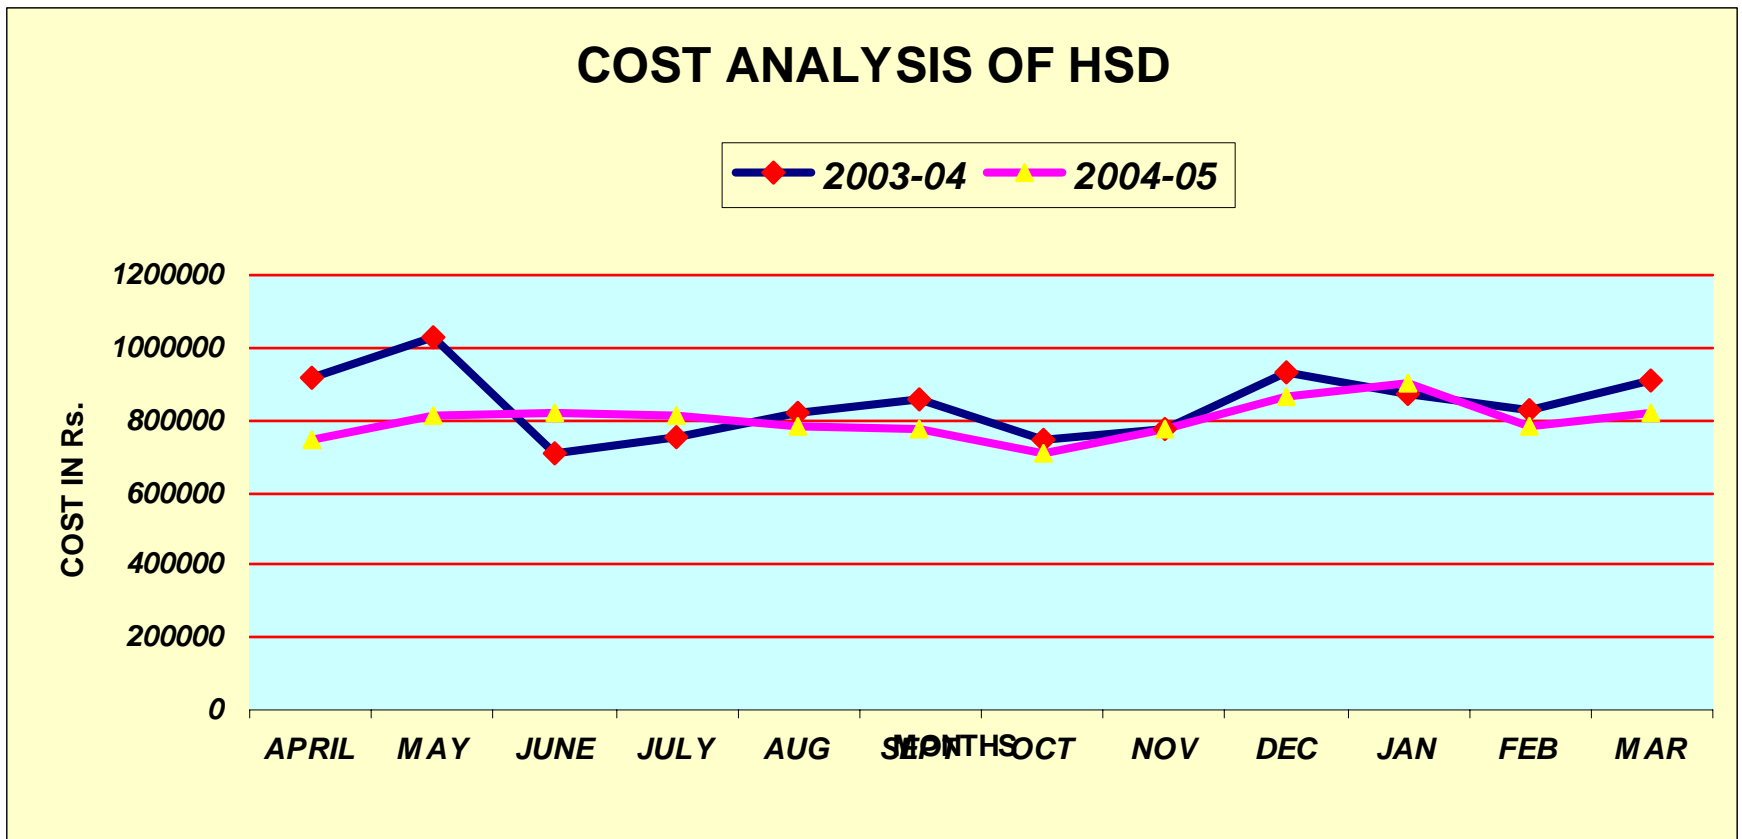
- The below graph signifies the comparison of HSD cost in the last two years
- The graph is not as effective as the HSD consumption graph in terms of savings because of a continuous hike in the diesel prices
- The avg. rate of diesel in the year 03-04 was Rs.21.3/lit where as the avg rate in 04-05 was Rs.25.2/lit. Hence the decrease in consumption was mark able in spite of the difference in the acting load.

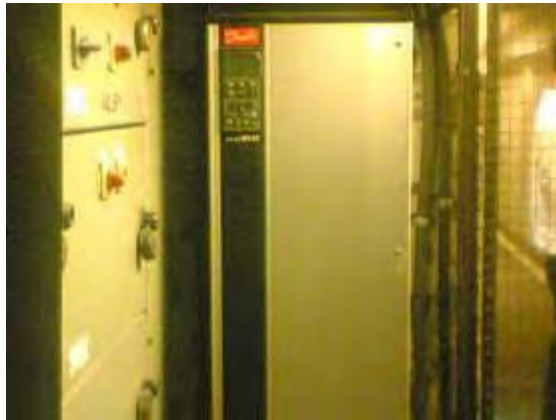
Installed VFD

- It was observed that the banquet kitchen exhaust was also running at full load at full speed where as the same was not required, hence to operate it as per the requirement the exhaust was fixed with a VFD and following are the results:
- Savings achieved : 9.54 kw
- Hours of operation : 24 hrs/day.
energy tariff : Rs.4.55/kwh
savings/year : Rs.75000.
date of implementation : 06/09
- It was found that the Pan Asian AHU was running continuously for the whole day at full load where as the peak load was only at the time of lunch and dinner when the occupancy was high hence in order to optimize the loading a VFD was installed for the AHU.
- Savings : 5 kw
Hours of operation : 24 hrs/day
Energy tariff : rs.4.55/kwh
Savings/year : Rs.2 lakh.
Cost of installation ; Rs.75000/-
Date of implementation : 25/02

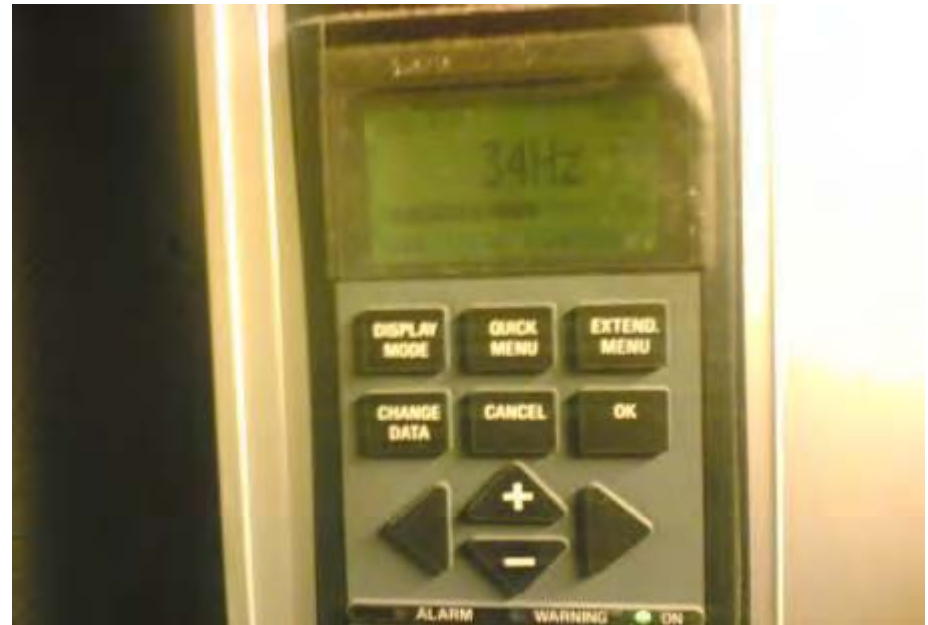
Display signifying the modulation of speed of the VFD depending upon the load

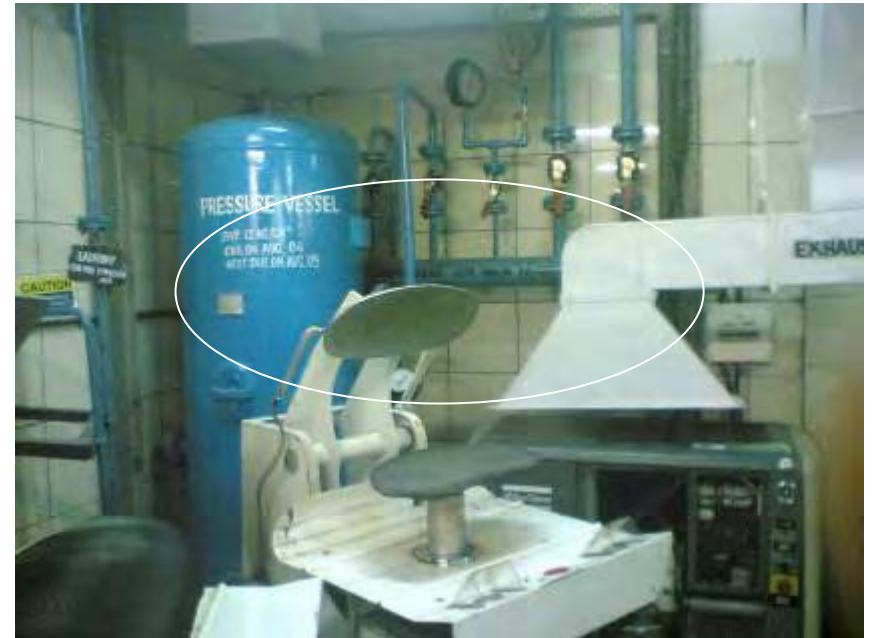
The highlighted place determines the place of installation of receiver and PRV in the outlet line of the compressor

- it was found that the unloading time of the compressor had increased because of various air leaks in the line
- At the same time the pressure maintained was not constant .
- To avoid these problems the system was installed with a receiver, PRV and by arresting various identified leaks resulting in the following :
 - Average ideal running hour/day previously : 16.45 hrs
 - Average kwh consumption /day previously : 72.38 kwh.
 - Average ideal runing hour/day after installing the receiver. : 5.73 hrs.
 - Average kwh consumption ?day now : 25.212 kwh
 - Savings achieved /day : 47.16 kwh
 - Savings achieved /year : Rs.78321/-
 - Cost of implementation : Rs.50000/-

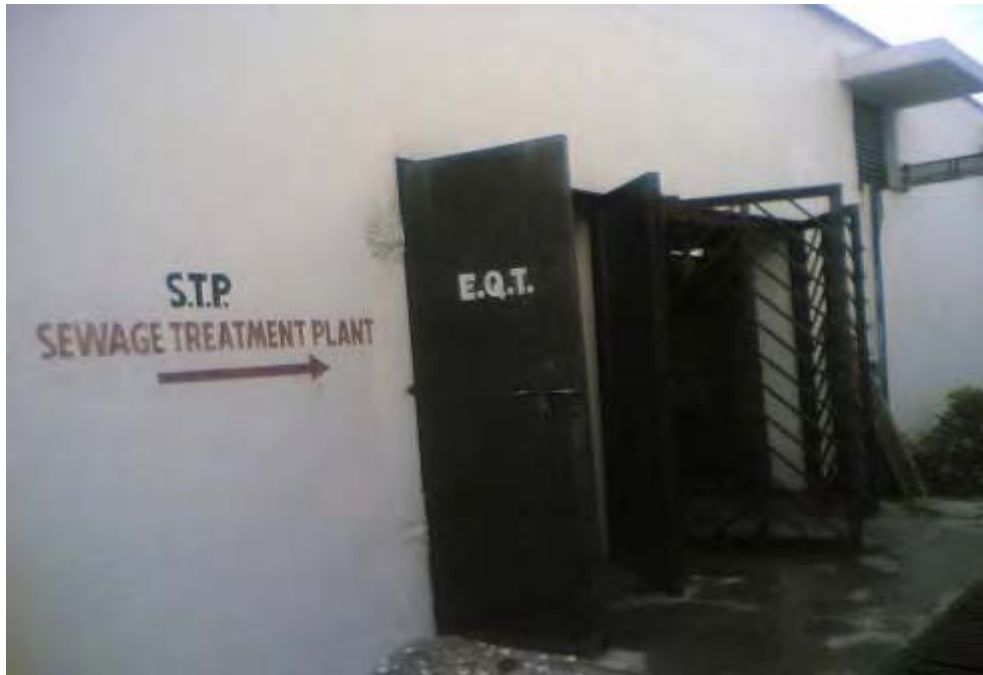
A. The main entrance for the STP area showing the open space entry of the plant

- The waste water treatment area is build in an open area of the hotel and had many openings .
- Still there was a provision of fresh air supply through fans which were continuously running resulting in wastage of electrical energy
- This was restricted by stopping the usage of fresh air fans there by maintaining the exhaust requirement by the outside air hence saving the mentioned energy.
- Savings : 2.2 kw
Hours of operation : 24 hrs/day
Energy tariff : Rs.4.55/kwh
Savings/year : Rs.87688/-

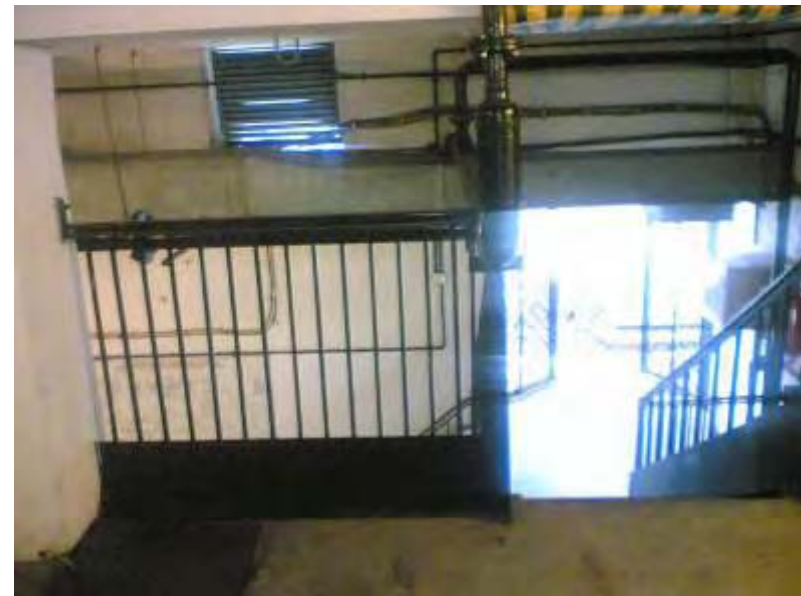
B. Inside pic of the plant room clearly indicating the amount of fresh air coming through the entrance

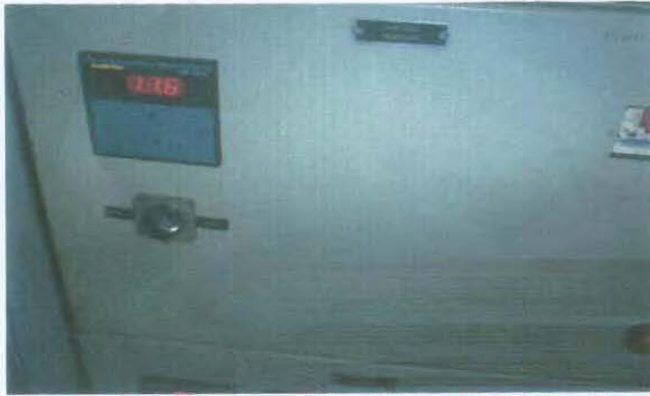
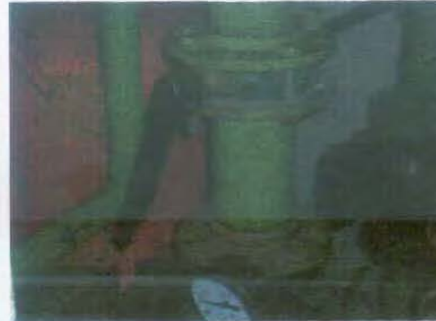
MAIN PORCH REFLECTION POOL CIRCULATION PUMP (BEFORE MODIFICATION)

VALVE THROTTLED

- Savings/hr : 1.04 kw
- Hours of operation : 17 hrs/day
- Energy tariff : Rs.4.55/kwh
- Savings in kwh/yr :6453.2 kwh
- Savings/year : Rs.29362/-
- Cost of implementation : Rs.2500/-

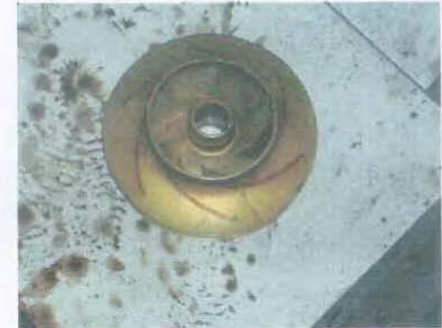
REMOVED IMPELLER

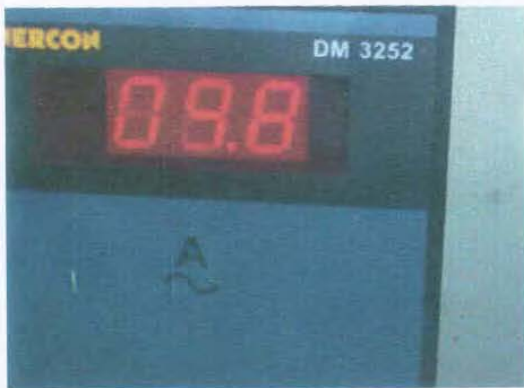
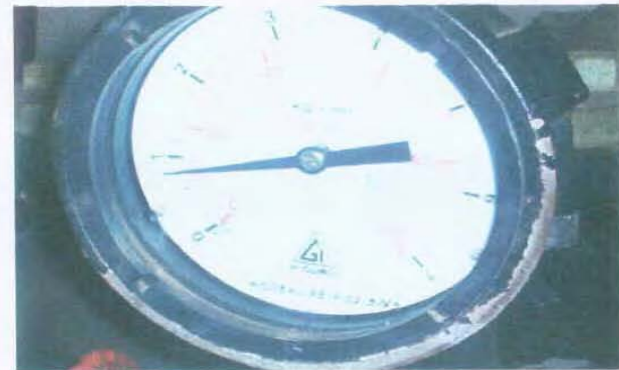
MAIN PORCH REFLECTION POOL CIRCULATION PUMP (AFTER MODIFICATION)

9.8 AMPs

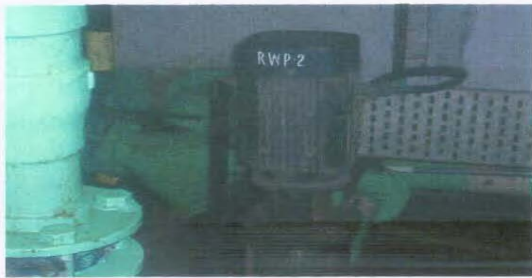
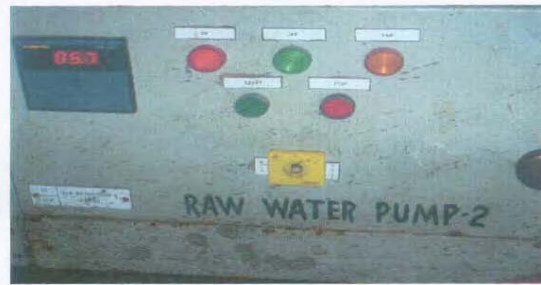
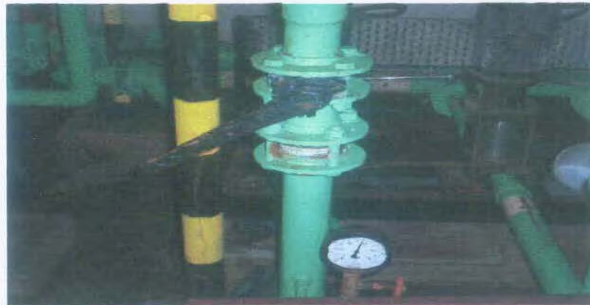
RAW WATER PUMP NO.2 (BEFORE MODIFICATION)

VALVE THROTTLED

- It was found that many of the pumps in different areas were of higher capacities as compared to what was required hence were drawing more power unnecessarily.
- Hence these pumps were modified by trimming their impellers and following were the savings achieved:
 1. **Raw water pump of R.O Plant :**
 - Savings : 0.99 kw
 - Hours of operation : 17 hrs/day
 - Energy tariff : Rs.4.55/kwh
 - Savings in kwh/yr : 6175.8 kwh
 - Savings/year : Rs.32422/-
 - Cost of implementation : Rs.2500/-

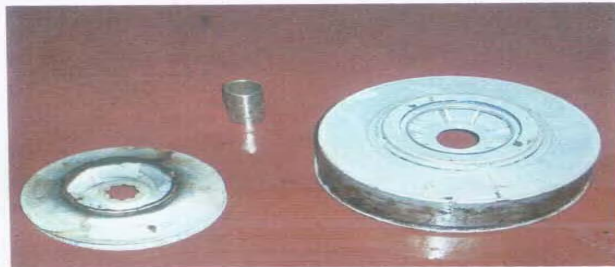
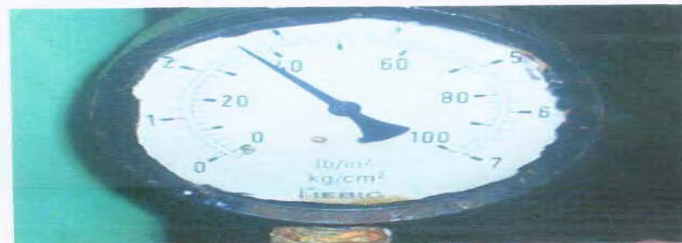
RAW WATER PUMP NO.2 (AFTER MODIFICATION)

SPARES REMOVED FROM THE PUMP

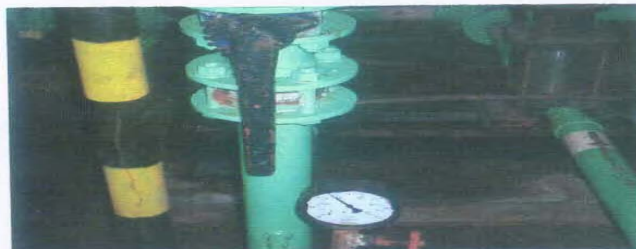
PRESSURE AFTER MODIFICATION

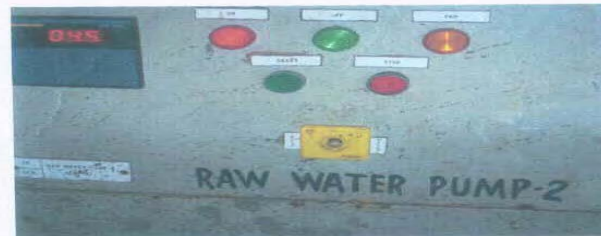
VALVE IN FULL OPEN CONDITION

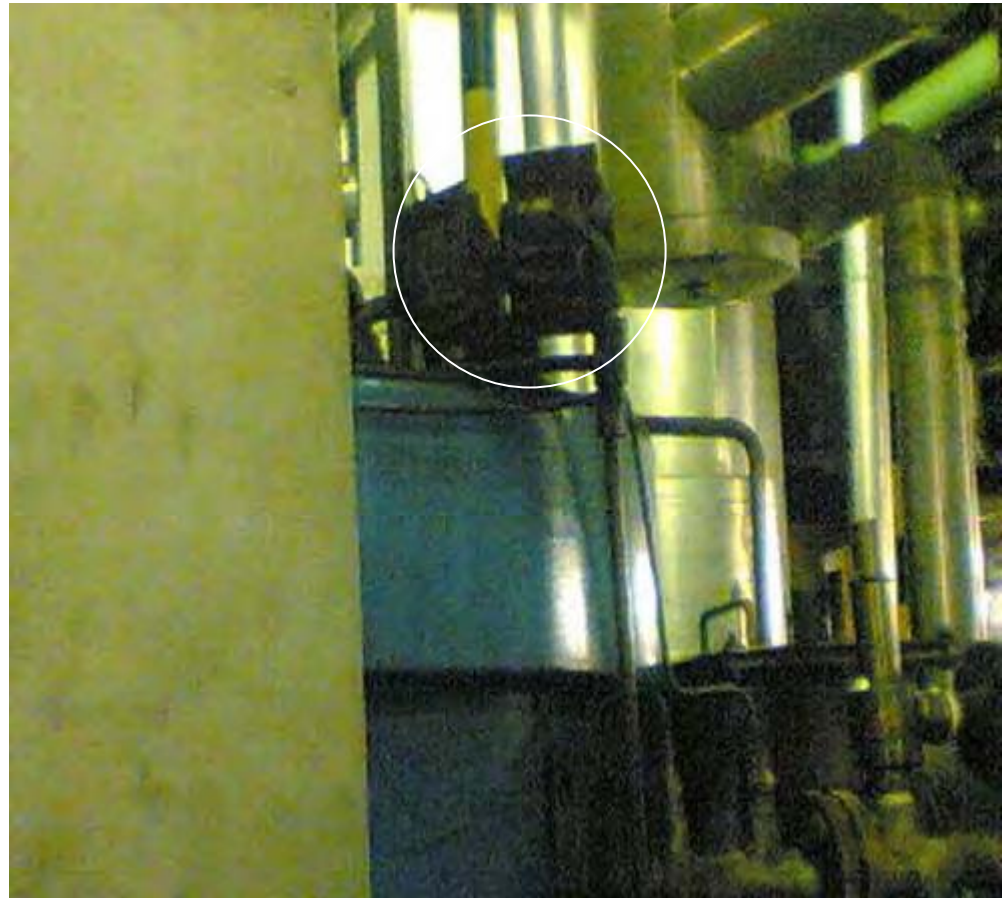
- It was observed that the combustion of fuel in the boiler was improper because of which many hydrocarbons were remaining unburnt and were vanishing in the form of smoke .
- This was rectified by placing a **magnetizer** in the fuel inlet line of the boiler,
- The magnetizer helped in the proper combustion of the fuel thereby reducing smoke and increasing the efficiency of the boiler .

The highlighted area determines the place where magnetizer is fixed at the inlet line of the boiler helping in proper complete and clean combustion
