STRATEGIES FOR REDUCING CEMENT KILN BAGHOUSE CORROSION PROBLEMS

For Presentation at the IEEE/PCA
Cement Industry Technical Conference
Vancouver, British Columbia
May 2001

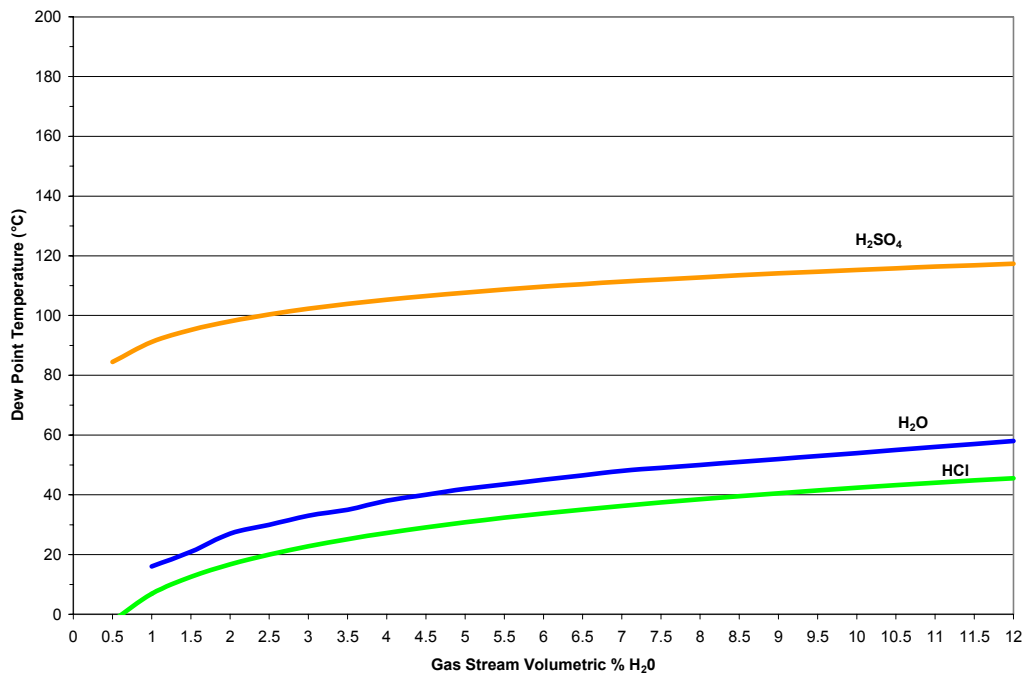
Figure 7 – Typical Hydrochloric Acid, Sulfuric Acid and Water Dew Points

Dew point is the temperature where water vapor condenses out of the gas stream. The dew point is highly dependent upon the percentage of water vapor and temperature of the gas stream. Very small amounts of water in terms of percentage of the gas stream build up to large quantities of water in the baghouse over a period of time. Acid dew point is the temperature where water that contains acid producing compounds condenses. The Sulfuric acid dew point is usually much higher than the water dew point, whereas the hydrochloric acid dew point is typically lower than that of water.

Controls should be adjusted to keep the dust collector hot, well above acid dew point. Fiberglass bags and membranes on glass bags can tolerate temperatures around 260°C (500°F) but last longer around 250°C (480°F). Operators should control temperatures as close to 250°C (480°F) as possible to prevent corrosion if they have acid producing compounds.
